Manhole Inspection Summary

Manhole # S29I__040MH

Insp Date: **9/8/08 2:14 PM**

Location Address: **105 Penn St**

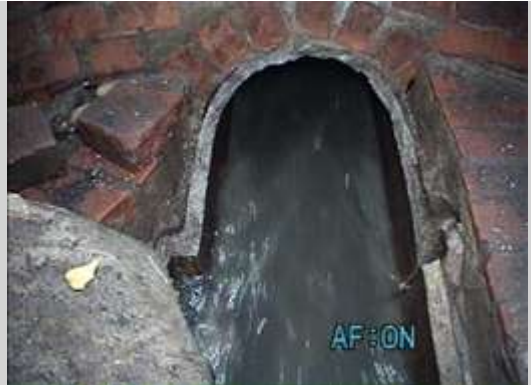
12 O'Clock Outflow

12 in. Circular Gravity Sewer
Pipe Out @ 12 O'Clock

Pipe Height: **12** (in.) Rod and Bar (Angled)
Pipe Material: **Clay** ☐ Pipe Lined
Invert Depth: **11.66** (ft.) Flow Characteristics:
Deposits: ☐ None ☐ Mud ☐ Sludge ☐ Debris ☐ Grease
Silt Depth: **0** (in.) Deposits Extent:
Infiltration: Pipe Seal Cond:

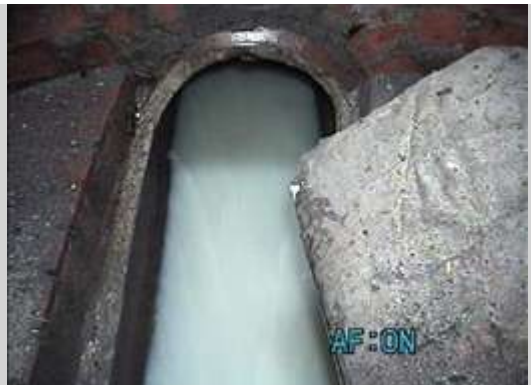
6 O'Clock Inflow

12 in. Circular Gravity Sewer
Pipe In @ 6 O'Clock

Pipe Height: **12** (in.) Rod and Bar (Angled)
Pipe Material: **Clay** ☐ Pipe Lined
Invert Depth: **11.63** (ft.) Flow Characteristics:
Deposits: ☐ None ☐ Mud ☐ Sludge ☐ Debris ☐ Grease
Silt Depth: **0** (in.) Deposits Extent:
Infiltration: Pipe Seal Cond:
